UNESCO-VISUS MULTIHAZARD METHODOLOGY

Mitigating the Impact of
Natural Risk in Africa
23-26 October 2017,
Cairo, Egypt

VISUS: A SUPPORT FOR DECISION MAKERS

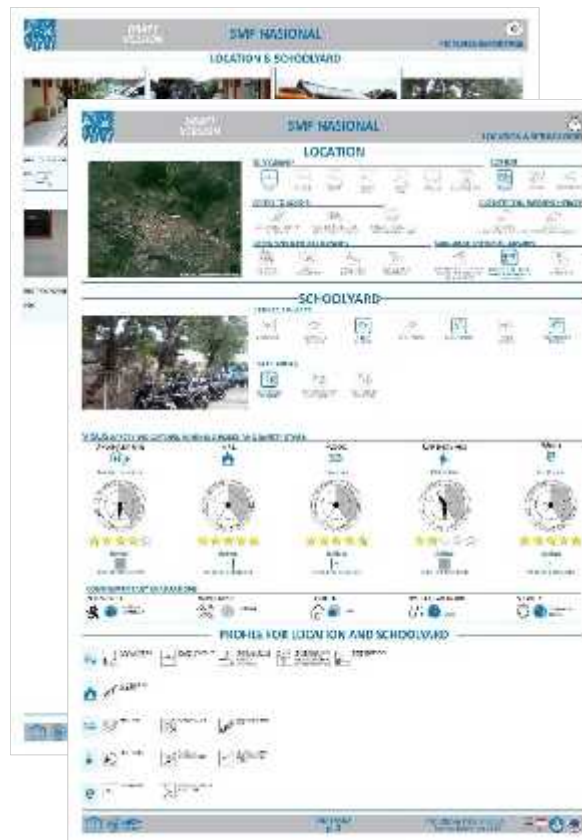
*Location and schoolyard
and photo reportage*

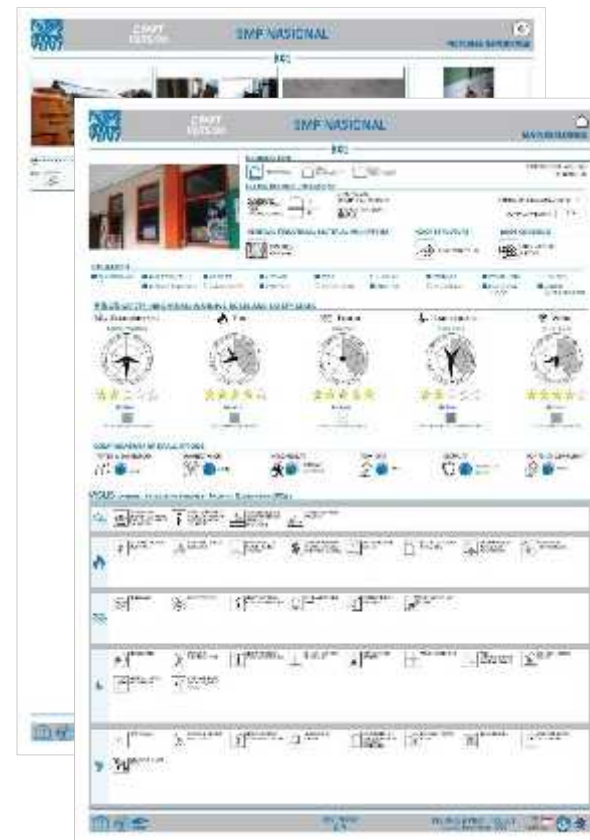
*School building
and photo reportage*

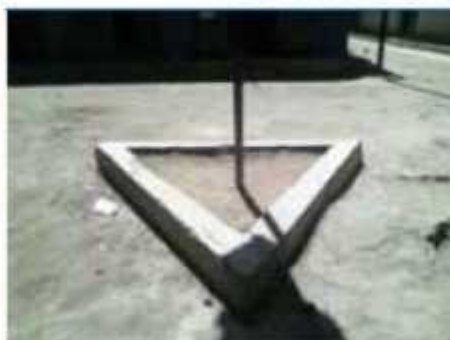
Obs: pot. falls due to uneven floor or tripping hazards; pot. hits with protruding objects or sharp objects.

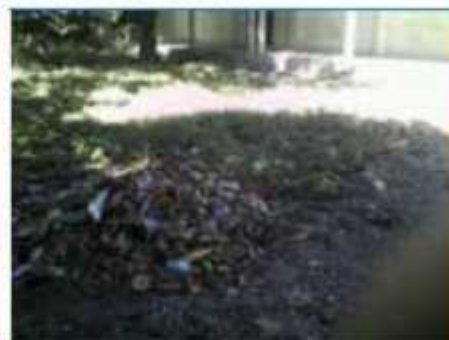
Obs: unrestricted waste collection or noxious area.

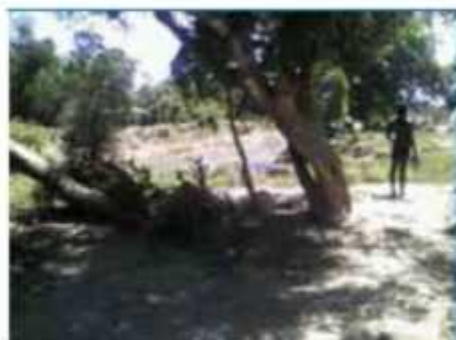
Obs: upstream highly erodible soil; open land - upstream; gentle or no slope - upstream; potential scour could impact the school complex.

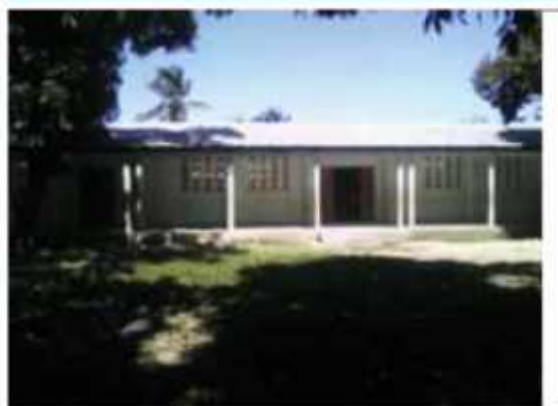
B01

CONSTRUCTION DATE: 2007

PLAN SHAPE:
SIMPLE, COMPACT
ELEVATION SHAPE:
SIMPLE

NUMBER OF STRUCTURAL UNITS: 1

AREA [m²]: 455

CONFINED MASONRY

SHEETS

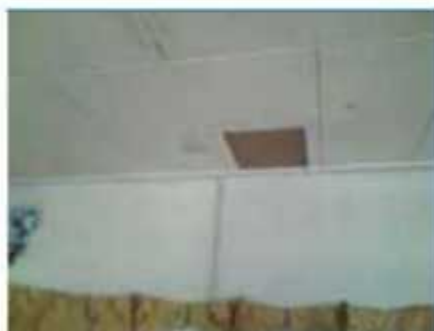
Obs: false ceilings.

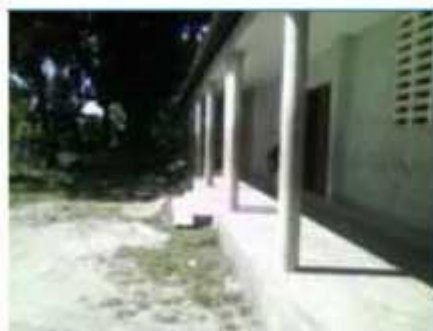
Obs: unprotected and accessible raised area; medium openings (windows, doors) always open; small openings always open; protected foundation (e.g. rip rap); limited access to building.

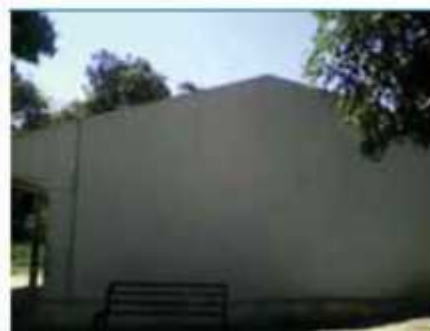
Obs: roof of veranda is extension of main roof; low slope; pitched roof.

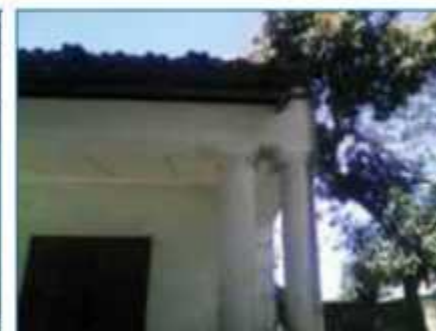
Obs: roof covering poorly anchored to structure.

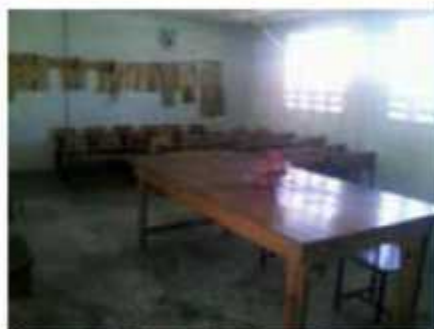
Obs: combustibles isolated; low light; moderate amount of books or wood-based furniture.

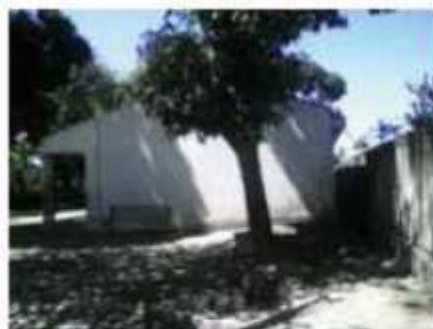
Obs: View of the building; pot. fall of trees or poles.

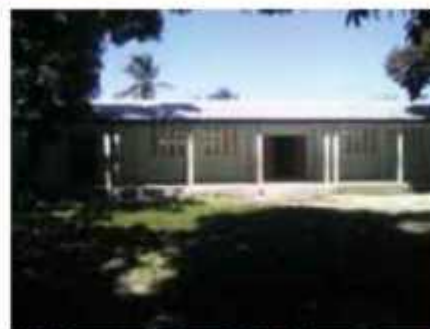
Obs: Representative picture of the building; medium openings (windows, doors) always open; small openings always open; sheets; permanent building; multiple exits in the building allowing the separation of people flows; main building; shallow foundation; free flow of water into building; limited access to building; confined masonry.

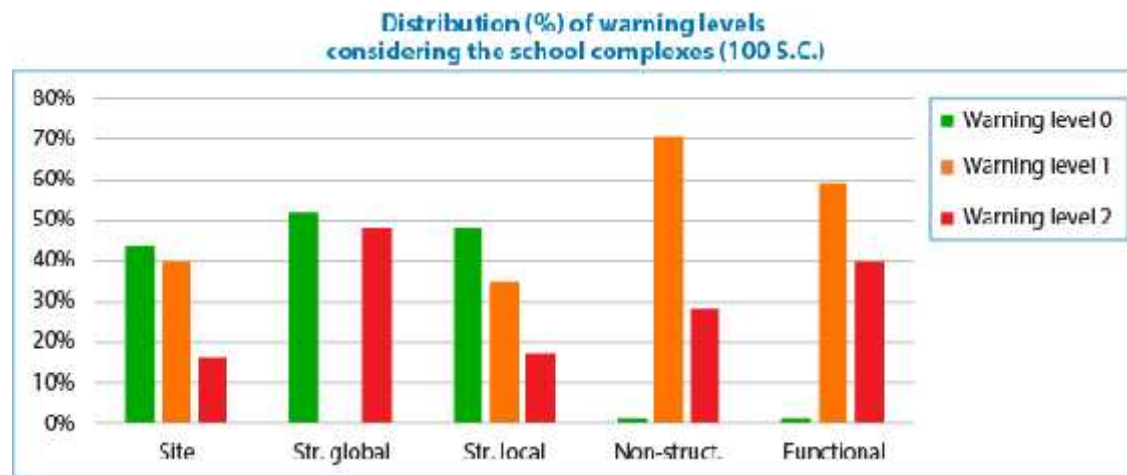
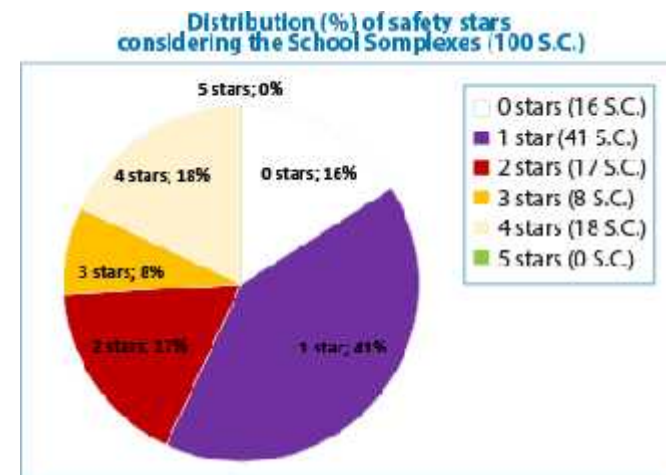
School complex (100 S.C.)

74% UNDER life safeguard performance

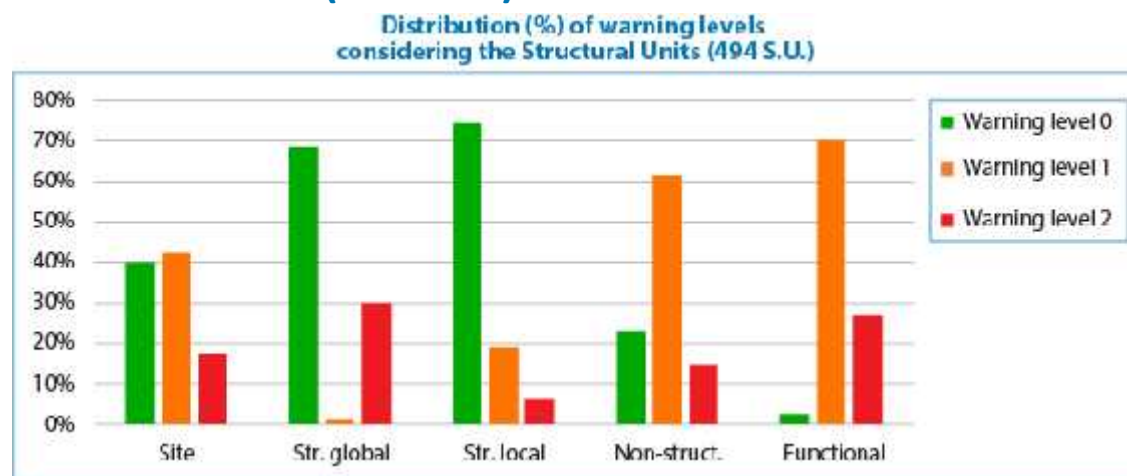
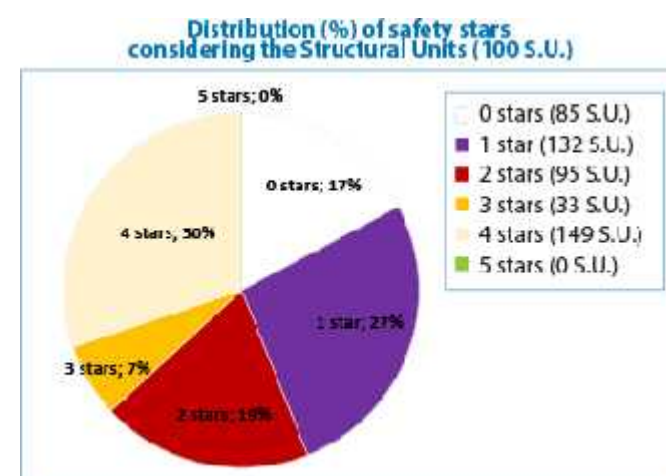
Structural units (494 S.U.)

63% UNDER life safeguard performance

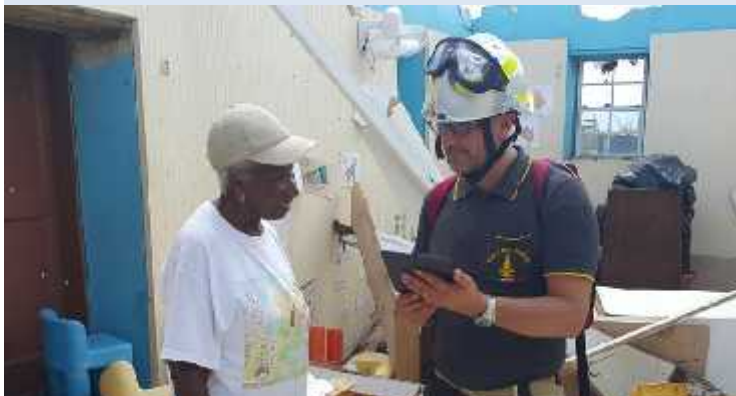
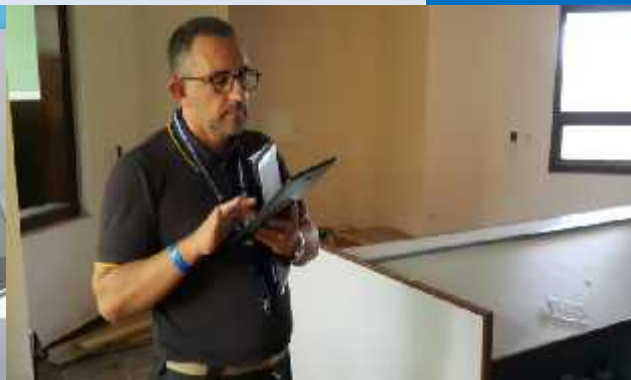
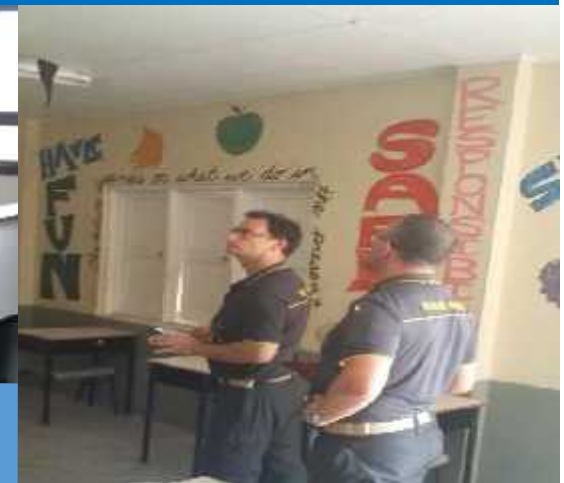
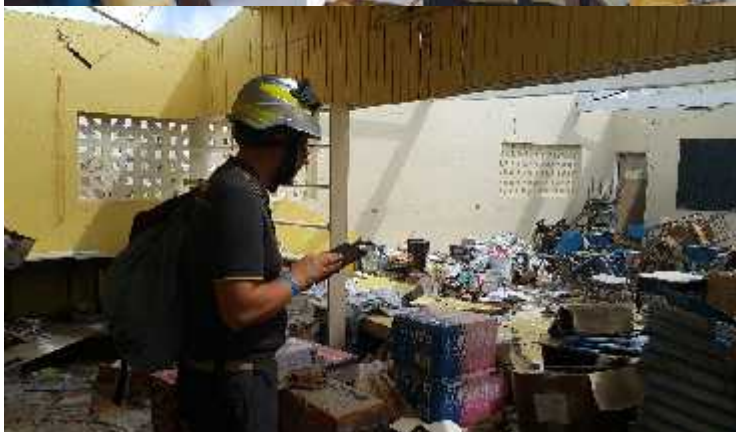
VISUS POST-DISASTER

- After Hurricane Irma
- 3-day mission to Barbuda on 2-4 October 2017
- 2 trained experts from the Italian Fire Corps
- 51 sites assessed
- Part of the Post Disaster Needs Assessment
- In collaboration with UNESCO Kingston Office
